RIVER REPORT

RUVUBU AND RUVYIRONZA RIVERS

BURUNDI

THE
WILDERNESS
PROJECT

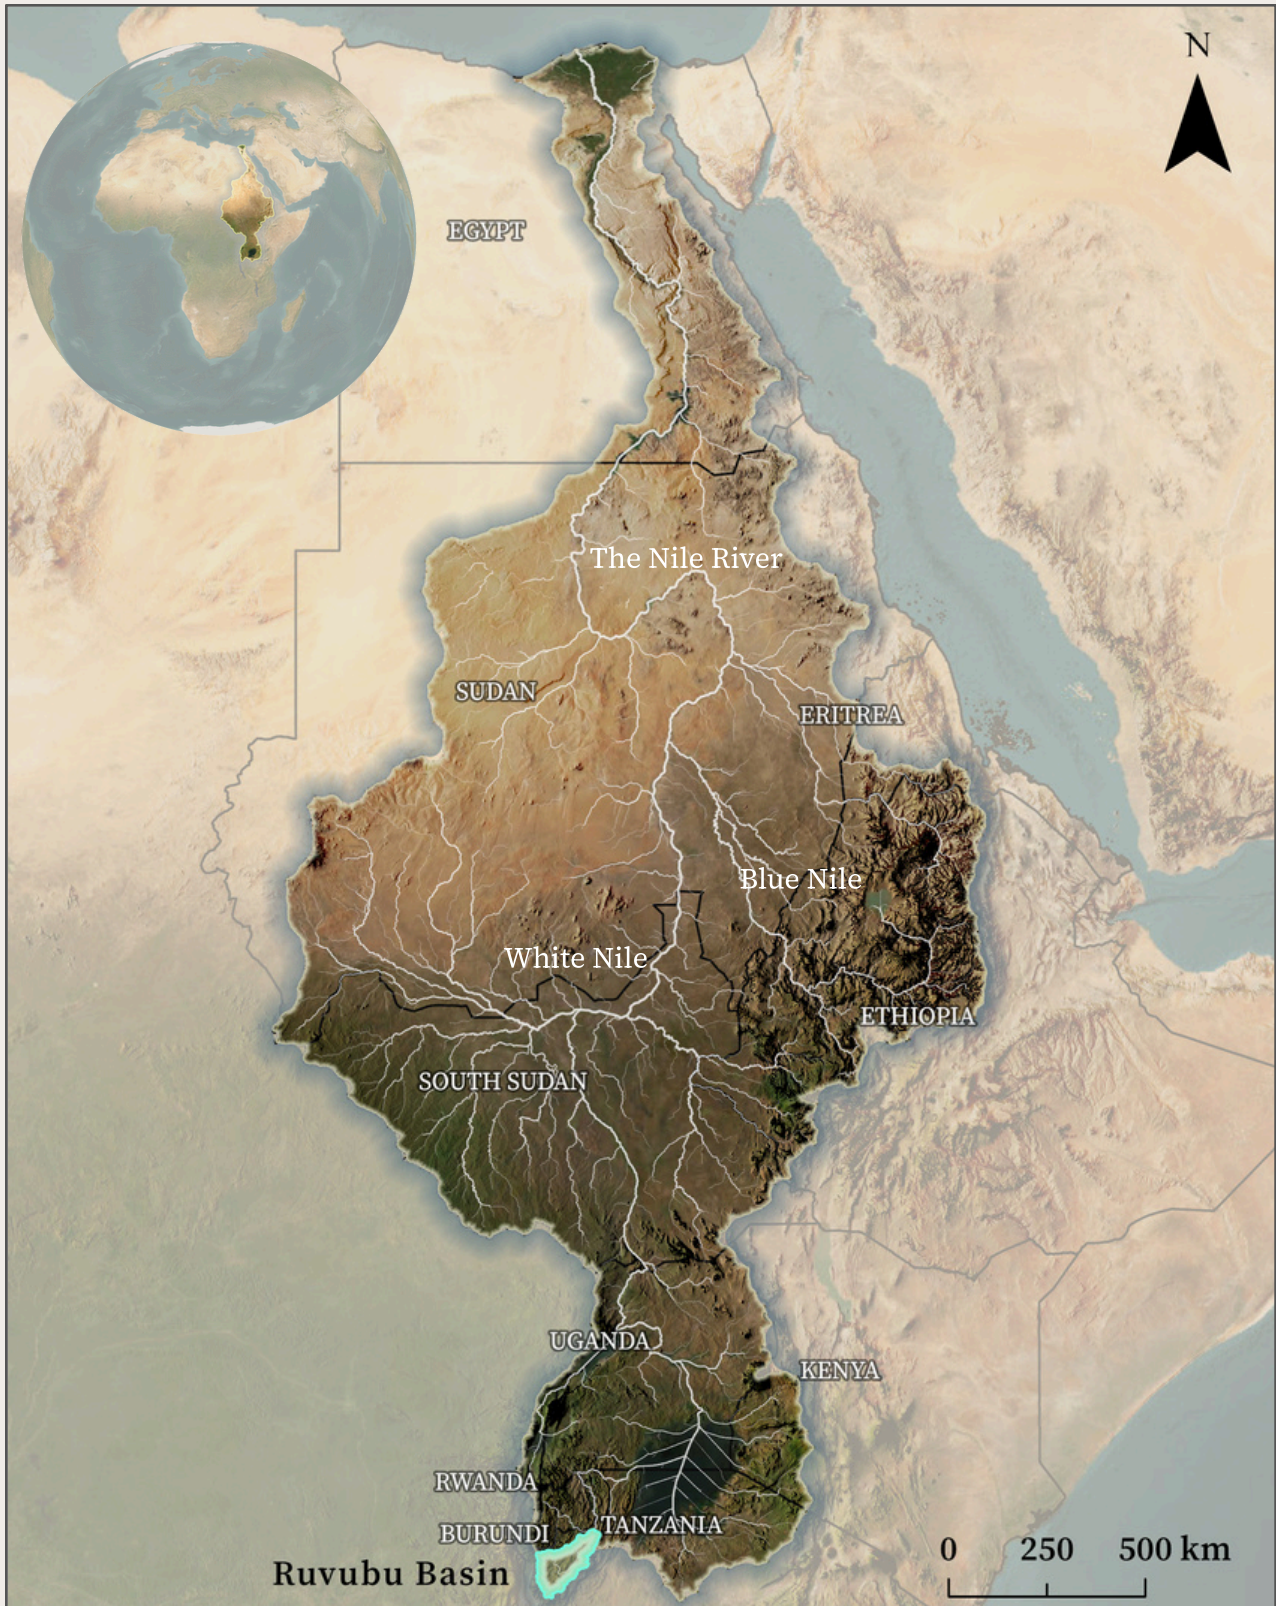
NILE RIVER BASIN

The Nile River Basin spans 3.4 million km², with the Ruvubu Basin representing just 12,176 km². Despite this, the Ruvubu Basin covers approximately 30% of Burundi.

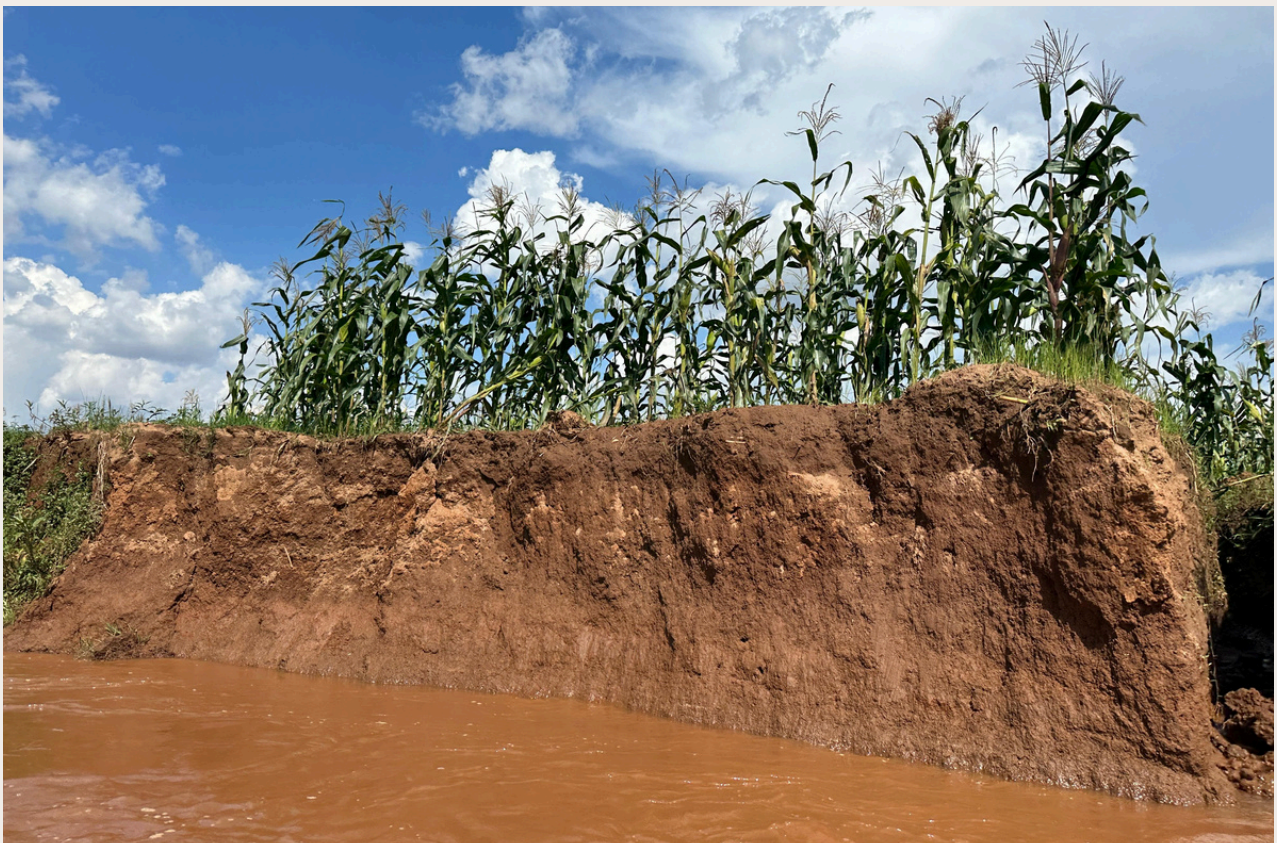
Severe riverbank erosion along a maize field contributes to increased sediment load in the adjacent water body. The exposed soil profile highlights the vulnerability of riparian agricultural zones to erosion, which in turn drives turbidity and downstream sedimentation issues.

Eroded topsoil contaminates the Ruvubu River, resulting in extreme turbidity¹ levels that are harmful to aquatic life (the maximum recorded on the transect was over 5,000 NTU). In addition, topsoil erosion reduces soil fertility, with potential impacts on crop yields and food security. Erosion is likely to rise under climate change conditions, which include an increase in extreme rainy days of up to 90% by 2100 [8].

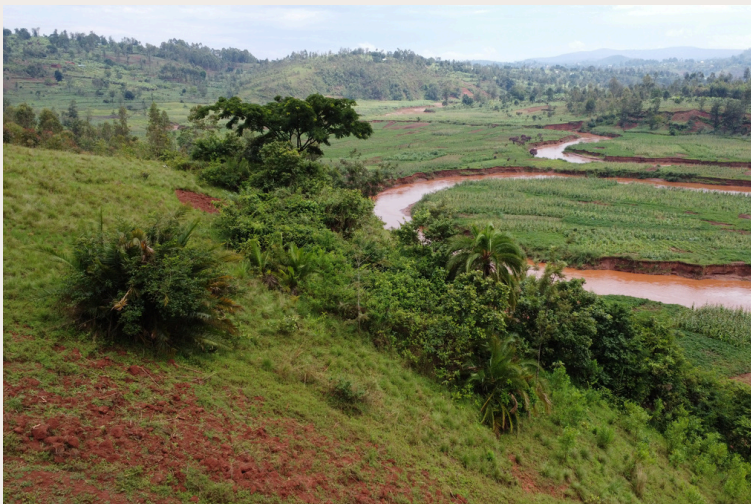
| Locations of potential restoration sites identified along the river transect.

Several isolated patches of indigenous vegetation were identified outside of the Ruvubu National Park. These were typically small (< 0.25 km²) and located in pockets of steep river meanders or on rocky islands. Importantly, these isolated patches of indigenous vegetation were all surrounded by agriculture, and in most cases were already being cleared to plant crops. Any future catchment management efforts aimed at restoring the Ruvubu should consider including these locations as pilot sites.

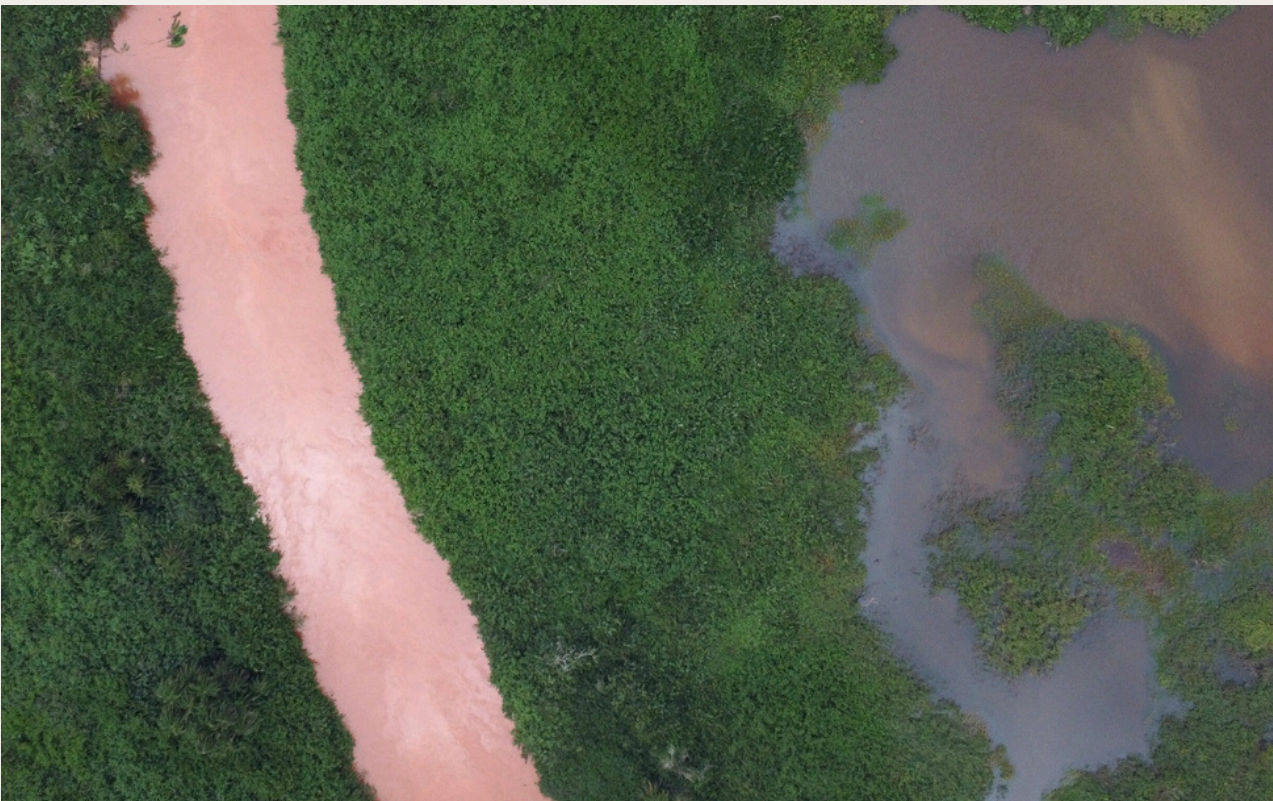
The colour of the Ruvubu River (left) contrasts sharply with adjacent floodplain lakes in Ruvubu National Park (right). The difference is due to upstream erosion, resulting in a high sediment load in the Ruvubu River. The floodplain lakes of the Ruvubu National Park are comparatively clear because of filtration by wetland vegetation and settlement of suspended sediments.

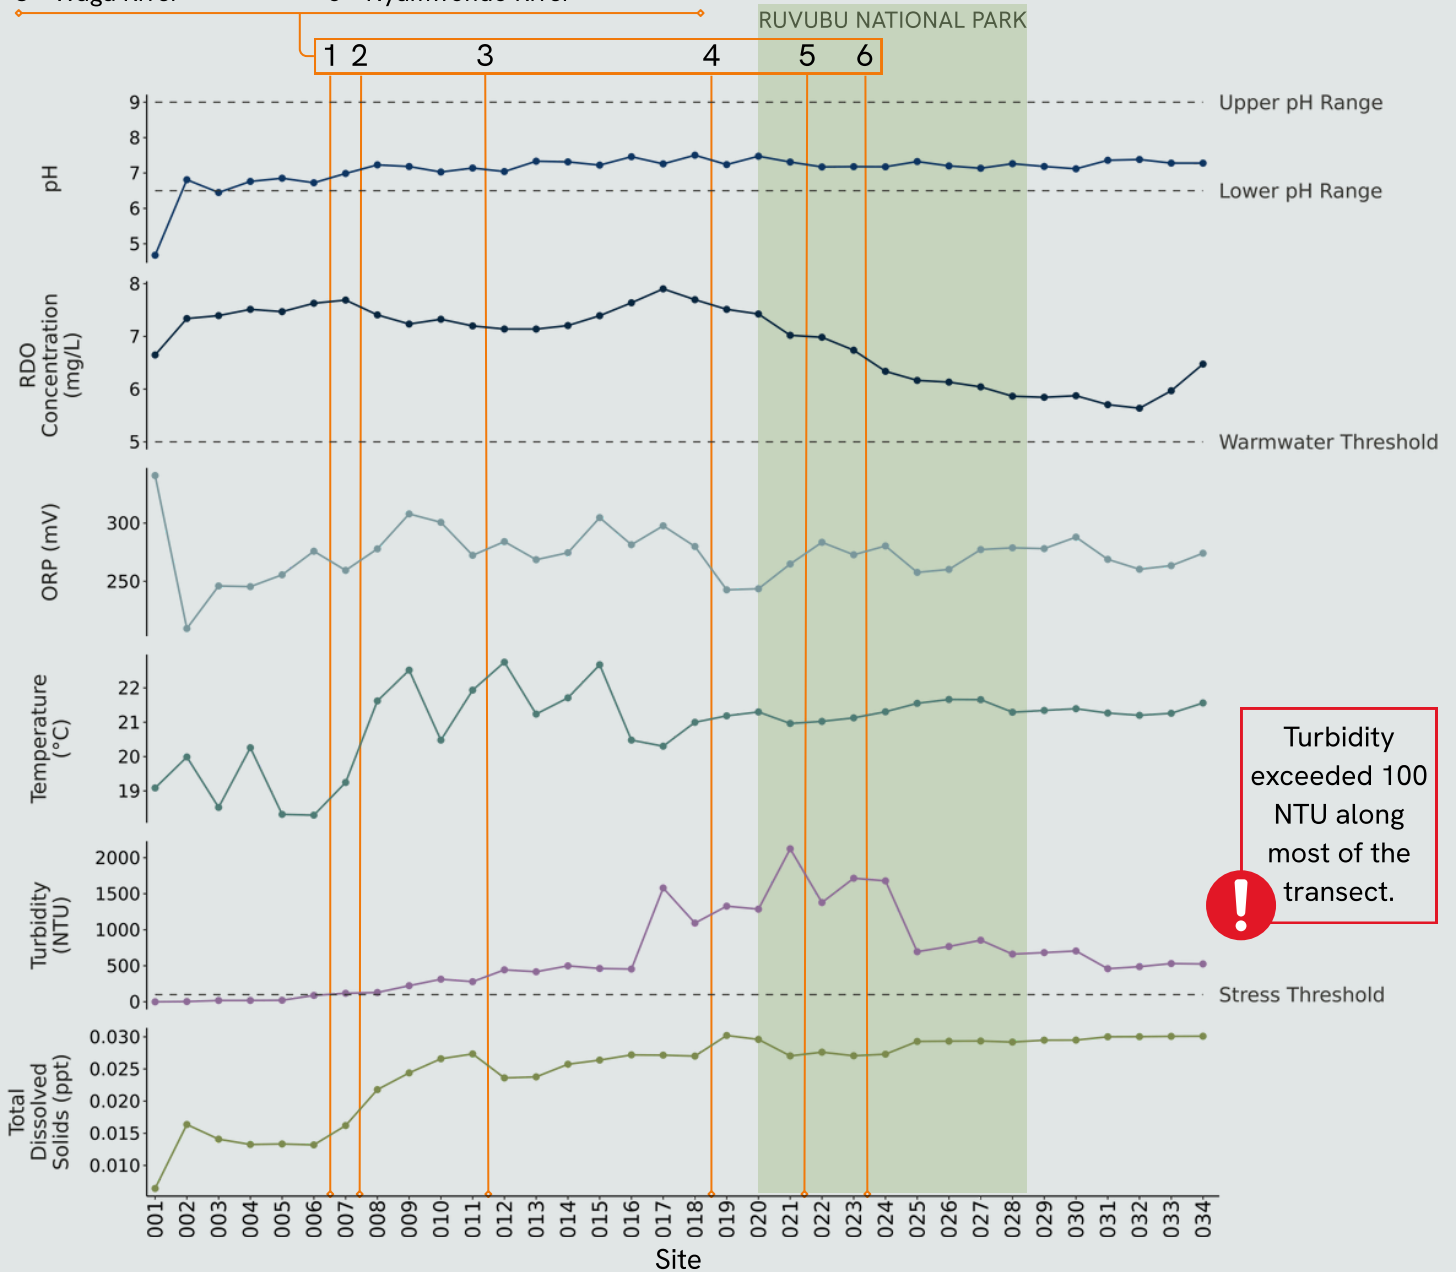
- 1 - Unknown Tributary 1
- 2 - Unknown Tributary 2
- 3 - Waga River
- 4 - Ruvyironza-Ruvubu Transition
- 5 - Kayongozi River
- 6 - Nyamwondo River

Turbidity exceeded 100 NTU along most of the transect.

In November of 2024, heavy rainfall caused the turbidity of the river to reach over 5000 NTU (with an average turbidity of over 640 NTU). Such extreme turbidity may stress aquatic organisms by impairing feeding, clogging gills, and smothering eggs, potentially influencing the composition of fish, amphibian and invertebrate communities [16].

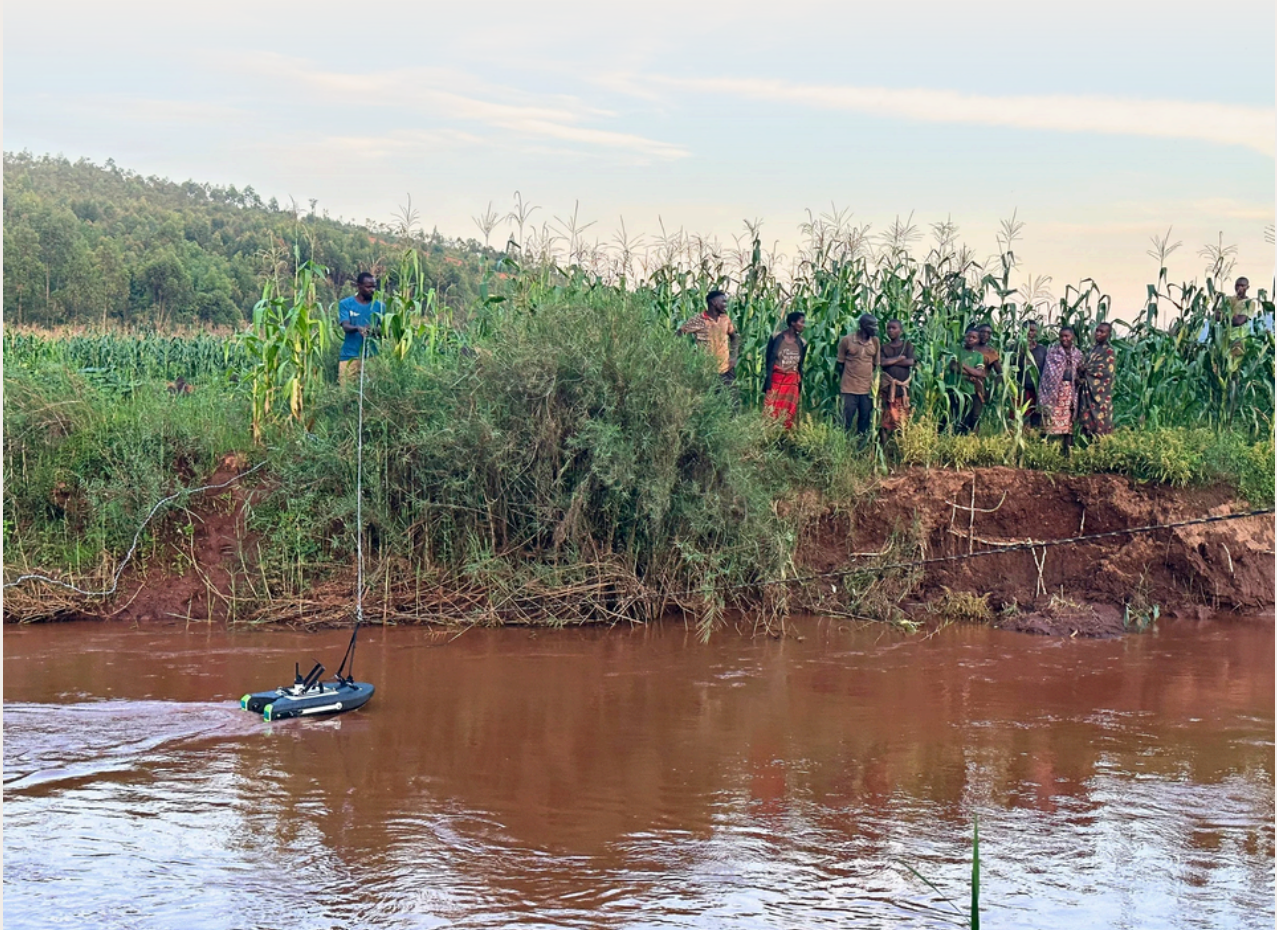
Ariel Nigarura from Université du Burundi uses the Acoustic Doppler Current Profiler (ADCP) to measure the flow of the Waga River, a major tributary of the Ruvyironza.

Burundi experiences its rainy season in February–May, with a shorter wet season between September–November. Discharge measurements were taken in November at the end of this ‘small rain’ season, therefore indicating conditions of high river flow. Flow measurements were collected at seven sites. These included i) one site on the Kibazo and Waga tributaries in the upper reaches of the Ruvyironza River; ii) three sites on the Ruvyironza River; and iii) two sites on the Ruvubu River.

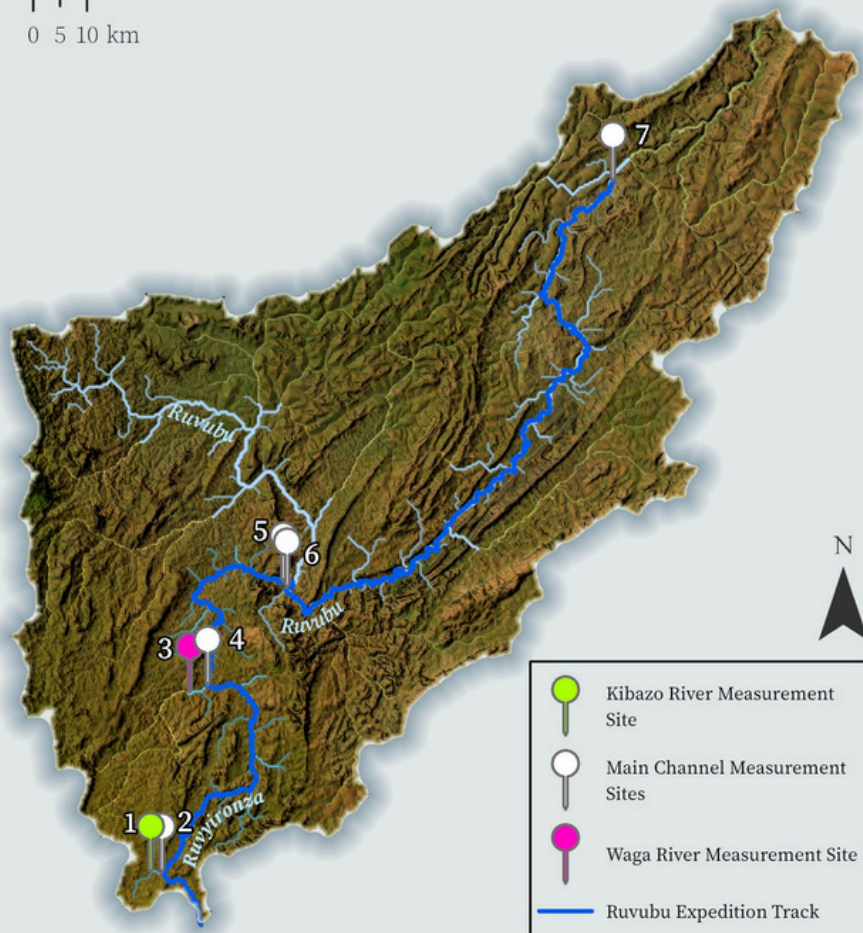
Site Number	Description	Discharge (m ³ /s)
1	Kibazo River	1.28
2	Main Stem (Ruvyironza)	1.72
3	Waga River	7.33
4	Main Stem (Ruvyironza)	7.03
5	Main Stem (Ruvyironza)	27.6
6	Main Stem (Ruvubu)	81.35
7	Main Stem (Ruvubu)	134.14

The Ruvyironza River and its tributaries contributed 27.6 m³/s to the flow of the Ruvubu River, accounting for 34% of surface water flow upstream of Ruvubu National Park. Similarly, tributaries within the park contributed substantially to the flow of the Ruvubu River before it entered Tanzania. The final flow of the Ruvubu River ~2 km from the border was 134.14 m³/s
